NCKRI SYMPOSIUM 2 Proceedings of the 13th Multidisciplinary Conference on Sinkholes and the Engineering and Environmental Impacts of Karst

PROCEEDINGS OF THE THIRTEENTH MULTIDISCIPLINARY CONFERENCE

May 6 through 10, 2013 Carlsbad, New Mexico

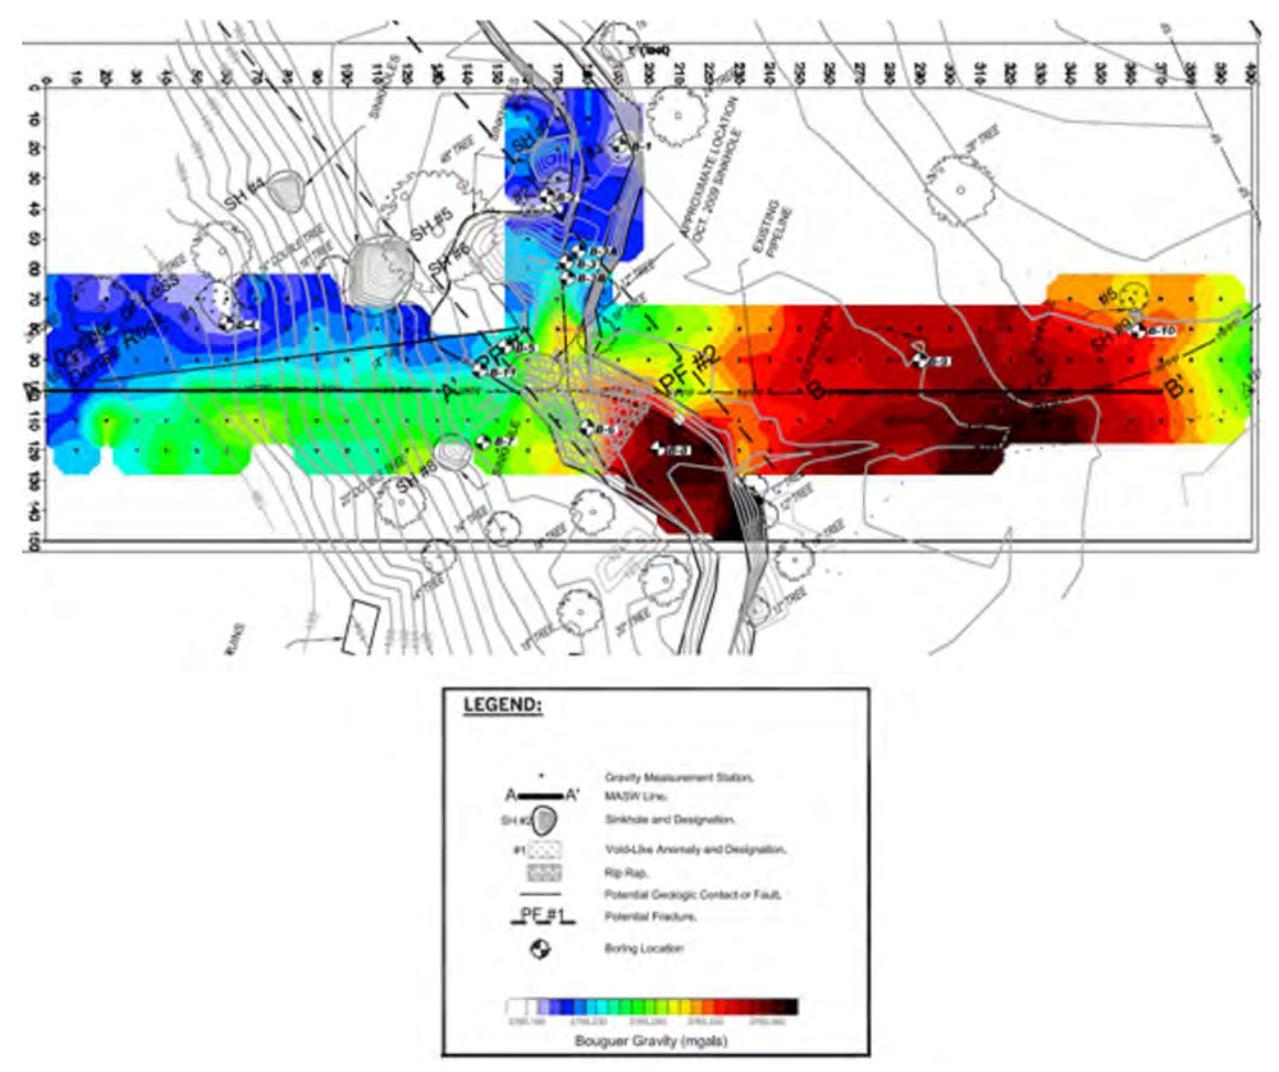
The results of the microgravity investigation clearly depict that subsurface conditions in the vicinity of the 2009 sinkhole location are highly variable with dense, shallow rock on the eastern and southern side of the creek and less dense, deeper overburden soils on the north and west side of the creek. Interpretation of the survey also revealed the presence of a potential fault that trends in a general northwest-southeast lineation. The fault extends between the pipeline and the northern edge of the pipeline right-of-way where the deeper overburden exists. Consequently, a majority of the sinkhole activity is on the north side of the fault. Two parallel fractures also exist in line with the creek and perpendicular to the fault line. It is significant to note that sinkholes have an increased risk of development in proximity to the intersection of fractures and faults in the underlying bedrock. Accordingly, at this site, sinkhole locations coincide with the location of intersecting fractures and faults. Further exacerbating sinkhole activity is that the topography generally slopes downwards in all directions

Figure 1. Microgravity results.

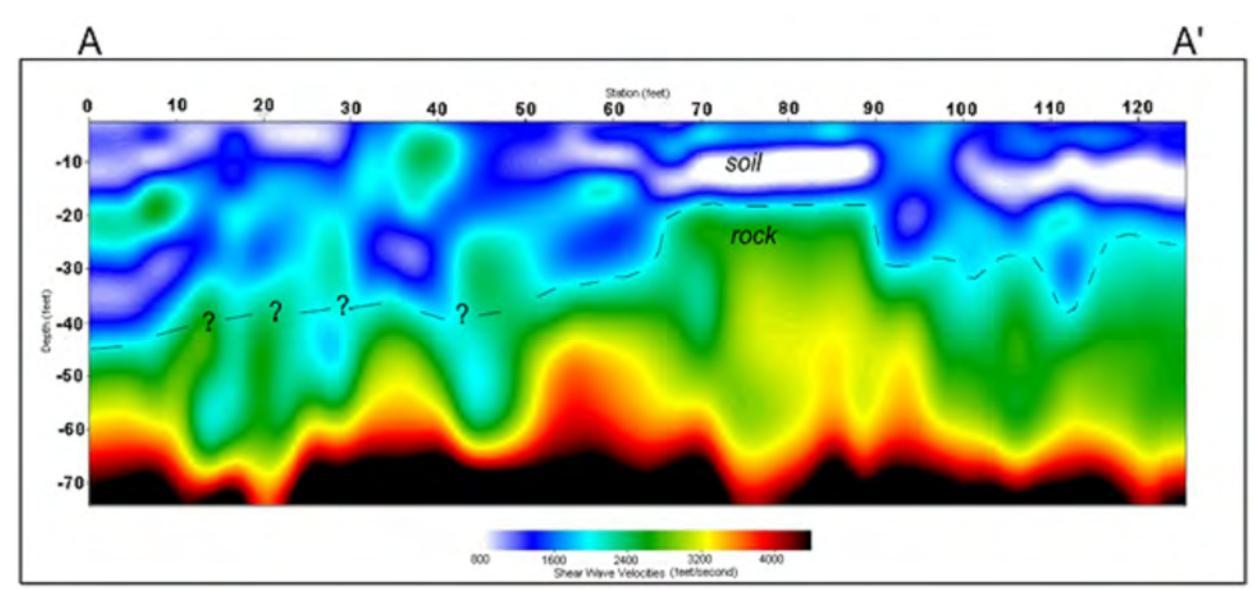
Following the microgravity investigation, the secondary geophysical method consisting of MASW was performed adjacent to the existing pipeline. The MASW method was used to provide a linear geophysical profile of subsurface conditions directly below the pipeline. The MASW could not be completed within the stream channel where rip rap was present. The MASW profile was generated from the interpretation of shear wave velocities generated by striking a plate attached to the ground. Geophones, spaced along selected intervals of the array record shear wave velocities as function of distance from strike point. From this data, material properties and depth to bedrock were estimated (Lee, 2010). The results are presented in Figure 2. After the completion of the geophysical investigations, 13 test borings were performed in proximity to open sinkholes, over anomalous subsurface conditions identified in the geophysical surveys, and where dense shallow bedrock was interpreted to exist. The intent of the test borings was to verify the conditions found in the geophysical investigations. Standard Penetration Tests (SPT) were performed at regular intervals throughout the borings until auger refusal was achieved. Following refusal

Figure 2. MASW results on western side of creek.

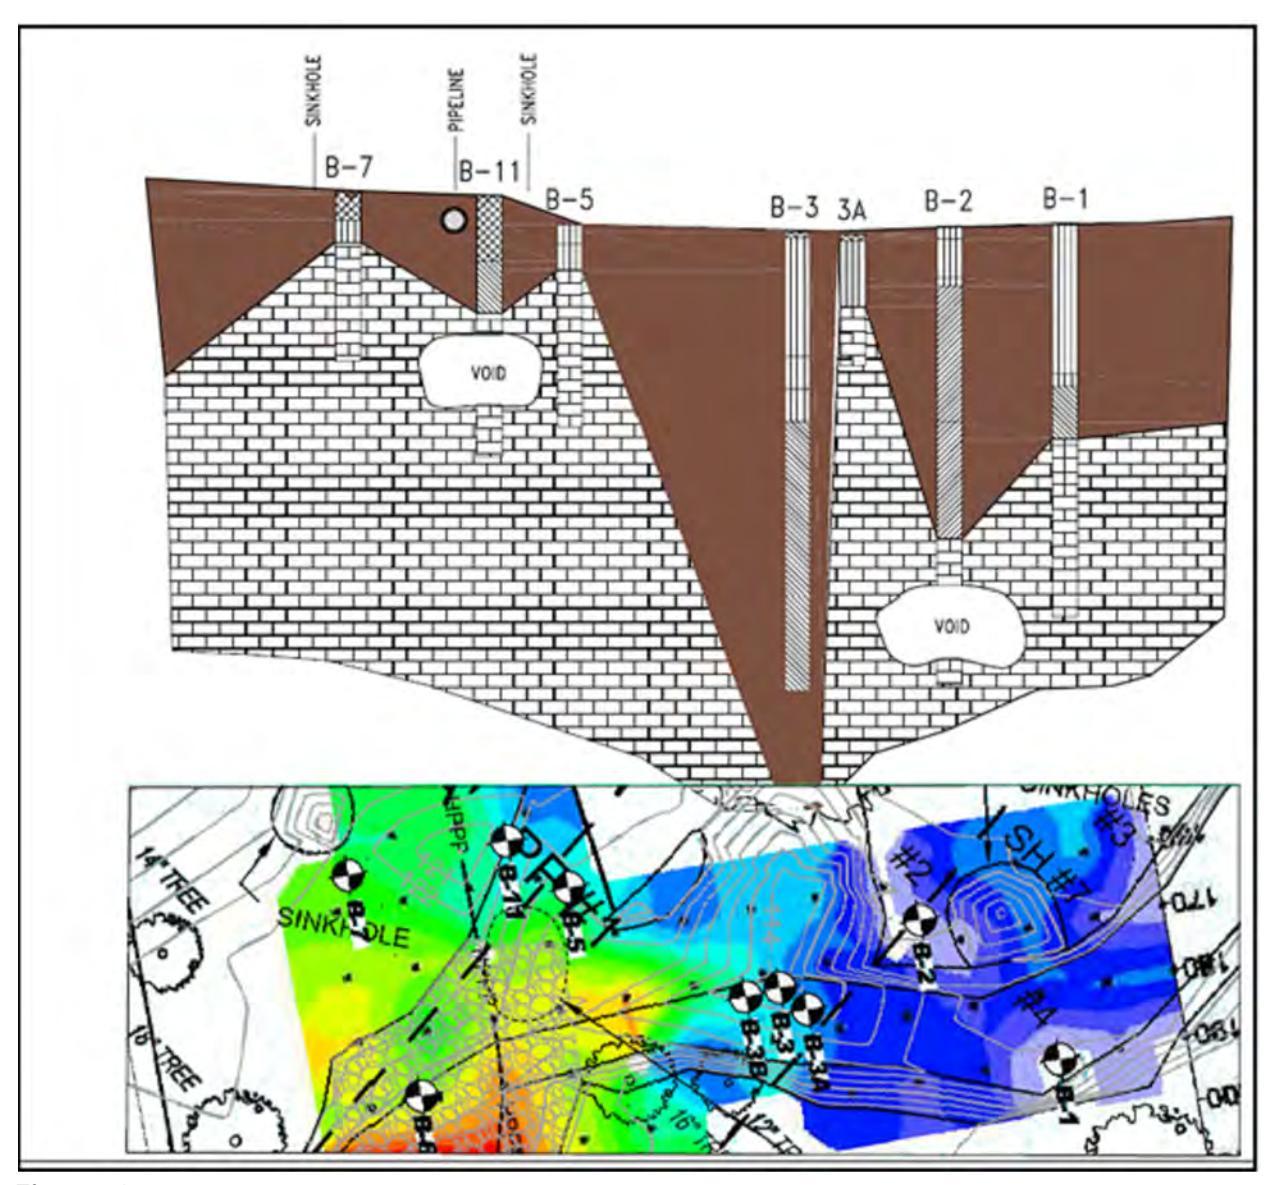
The results of the geotechnical investigation revealed that active sinkhole conditions were present in the existing pipeline right-of-way. As part of the scope of work, a budgetary value of \$600,000 was estimated for a remedial grouting operation within the pipeline rightof-way. Due to the extensive voids found in the borings, the large amount of grout required during the stopgap grouting operations, and the potential for extensive active sinkhole conditions near the pipeline, concerns were raised that the grouting costs could easily exceed the budget estimate. Therefore, a subsurface grouting program within the existing right of way was considered to be cost-prohibitive. Furthermore, due to the variable subsurface conditions and depth to competent bedrock found within the right-of-way, a deep foundation system to structurally support the pipeline was not considered viable due to the high costs associated with this option.

Figure 3. Test boring profiles results and a plan view of the corresponding microgravity results along the creek perpendicular to pipeline.

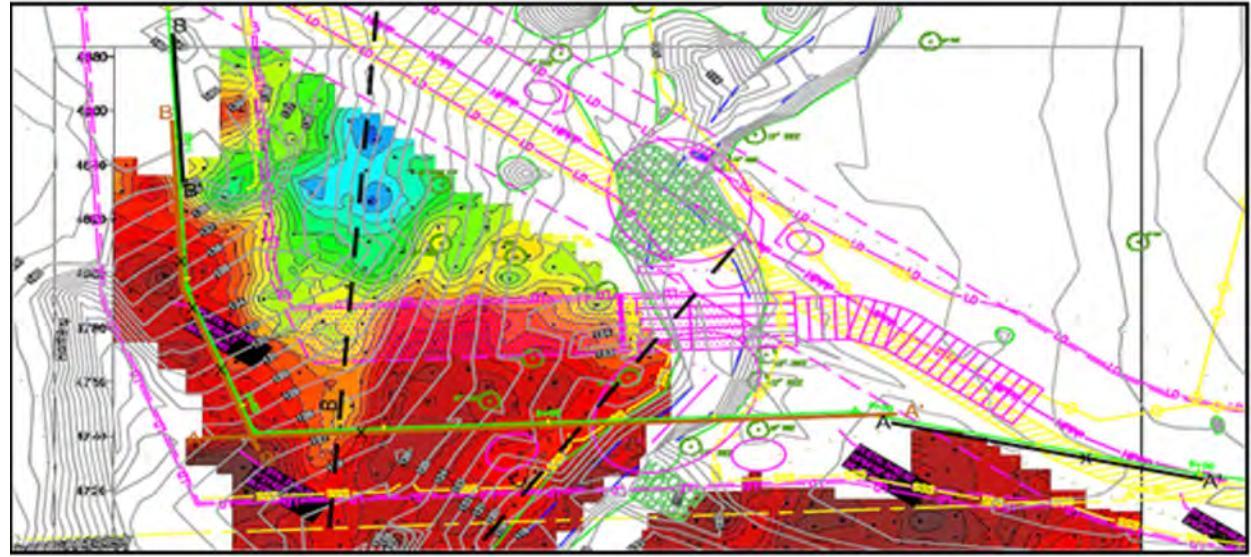
After the preferred relocation alignment was chosen, MASW and two-dimensional electrical resistivity (2D ERI) surveys were conducted to provide a linear profile of the subsurface conditions beneath the new alignment. The 2D ERI was used in areas of steep slopes or undulating ground surface. Following the geophysical surveys, test borings were drilled at anomaly locations

Figure 4. Microgravity results included with MASW & 2D ERI locations over the proposed realignment route.

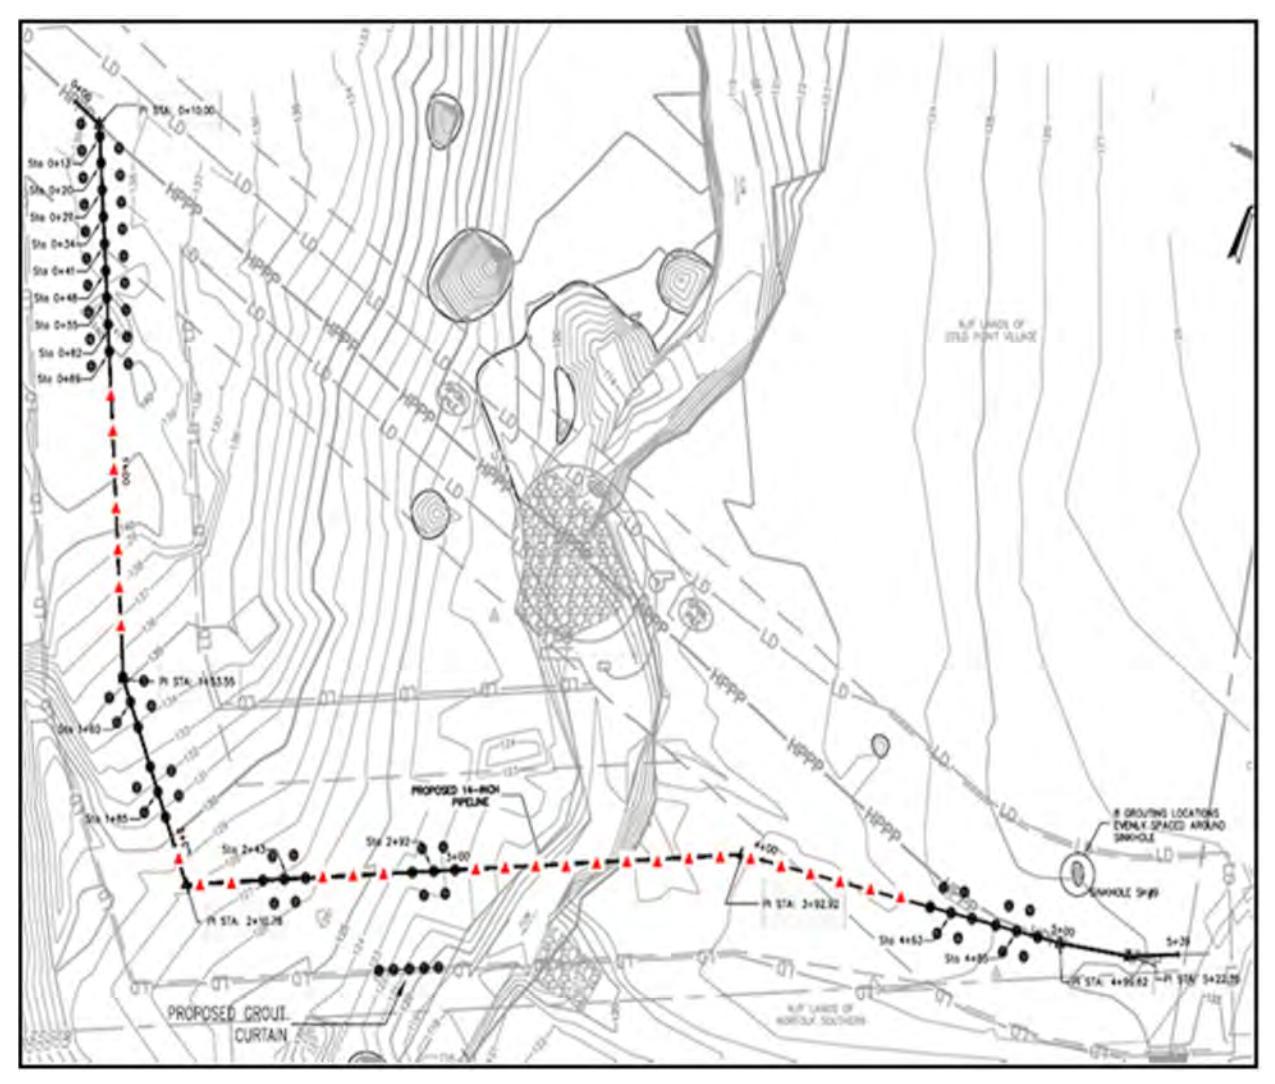
Figure 6. Proposed grouting location plan within realignment route.

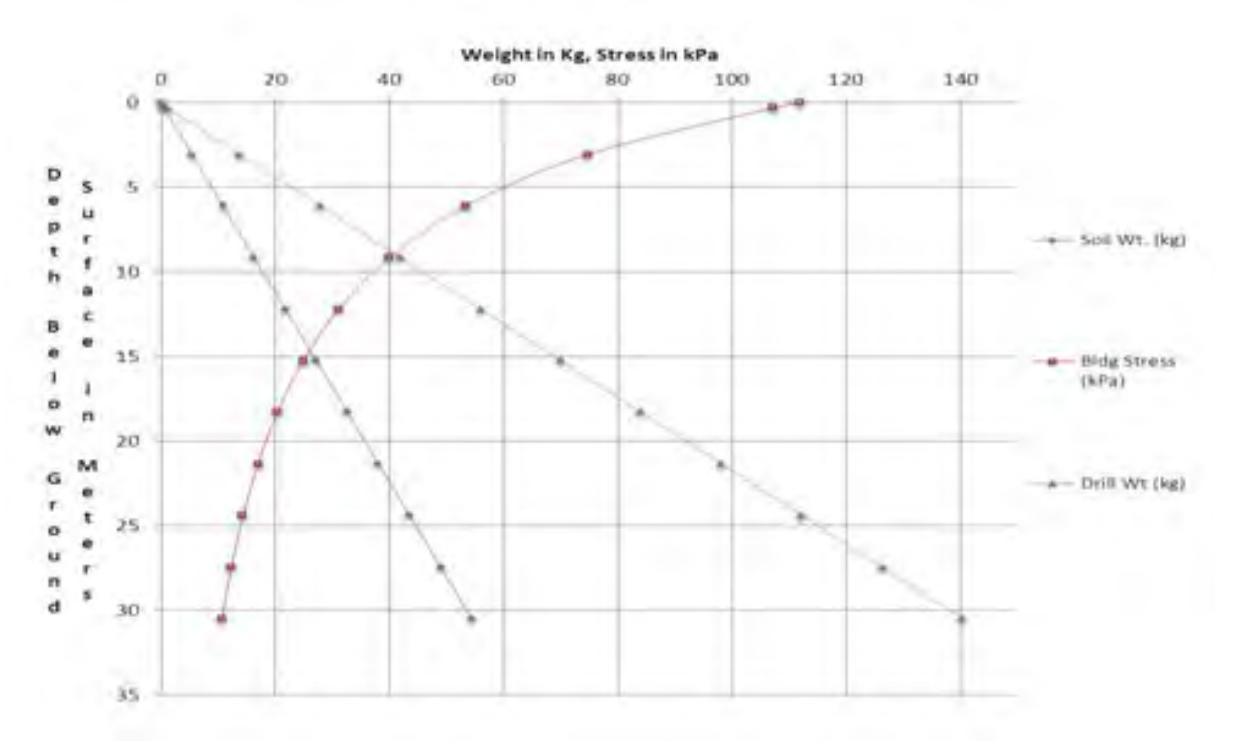
Figure 1. Comparison of Soil Weight with Weight and Stress of Drill String.

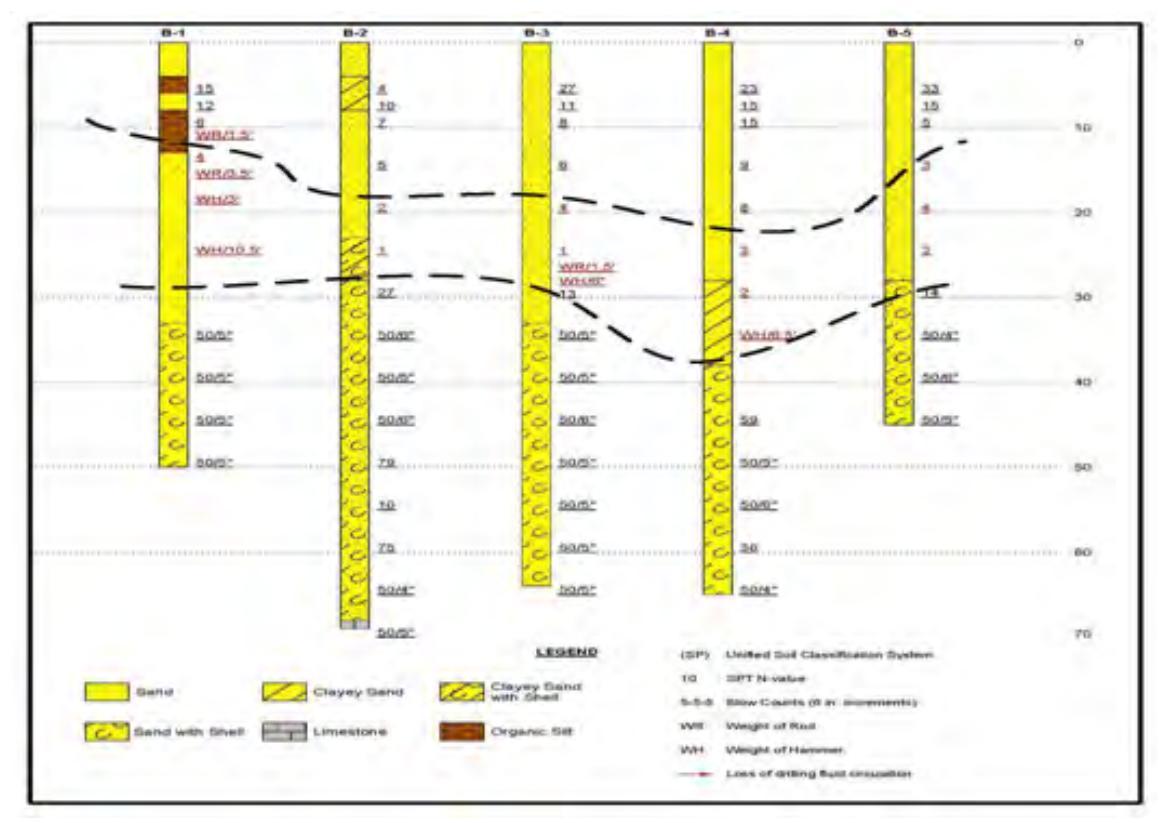
Figure 3. Case study No. 1—a Site Near the East Coast of Florida (red indicates N-values less than or equal to 4, depth in feet).

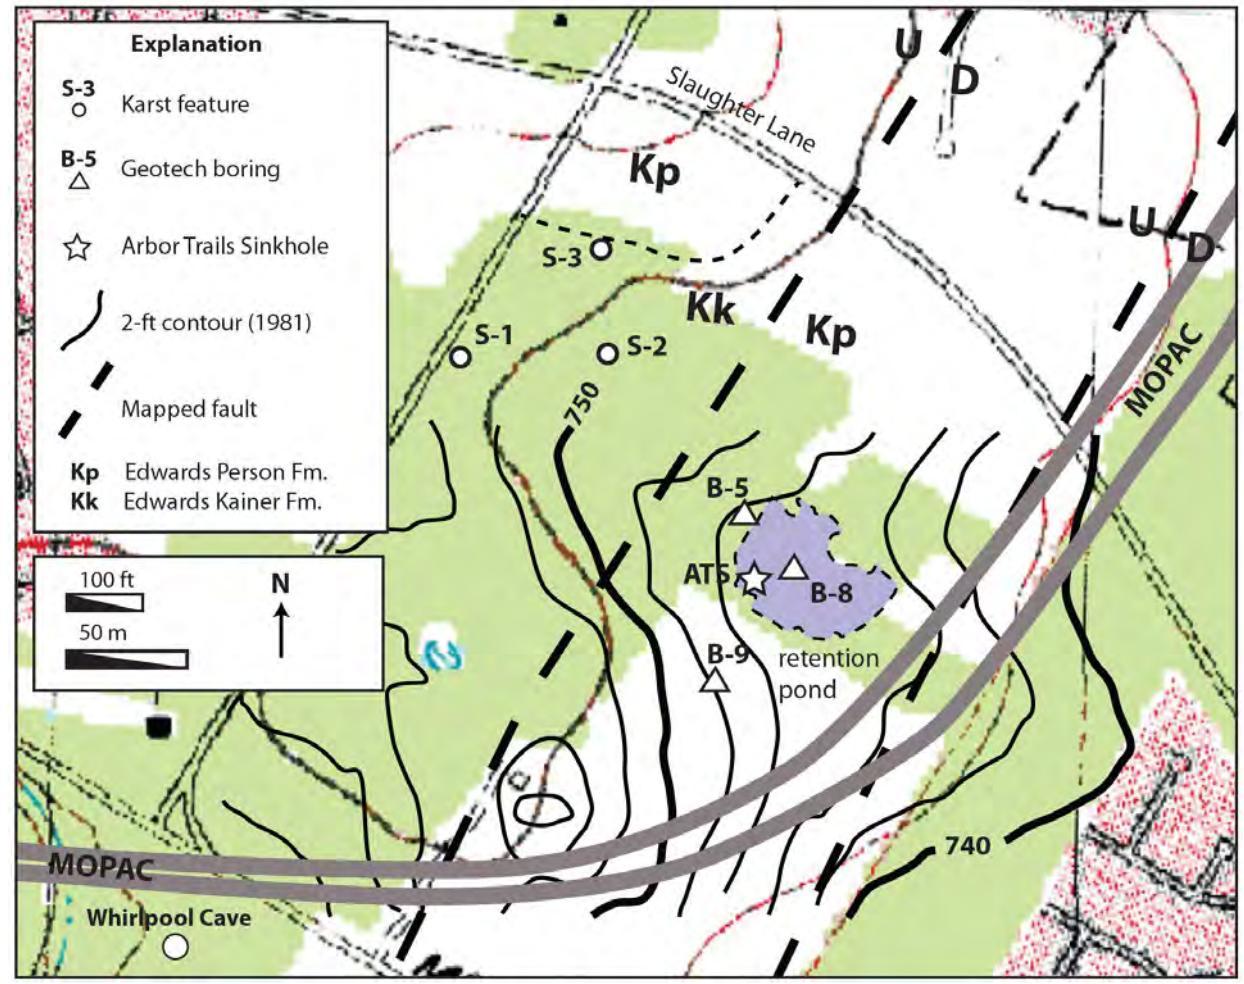
Figure 2. Predevelopment topographic map. Basemap is USGS Oak Hill Quadrangle (10-ft contours in brown). Geologic information from HBC/Terracon (2004). Geologic units and faults are consistent with Small et al., 1996. Black lines are City of Austin 2-ft topographic contours dated 1981, prior to major highway (MoPac). Contours create a depression centered around the SWRP (shown as dashed lines).

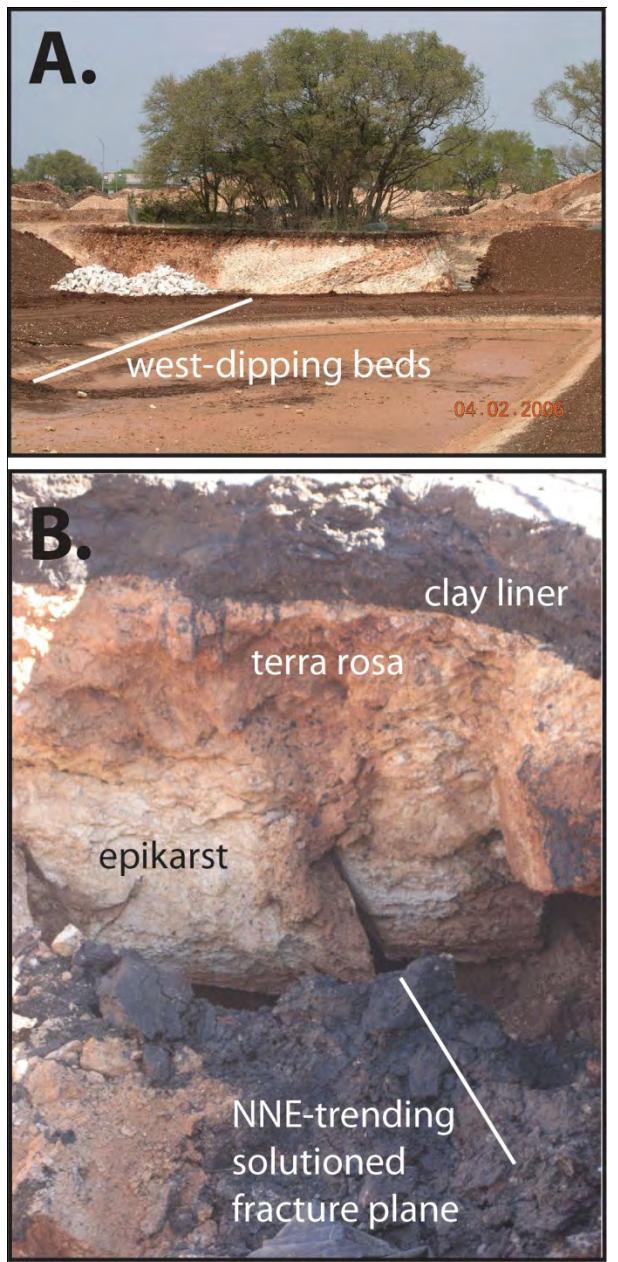
Figure 5. Photograph locations indicated in Figure 4. A) Photo during construction of SWRP showing west-dipping beds in the northern wall of the forebay (photo credit Andrew Backus, 4/2/2006); B) Photo of the northern wall of the sinkhole taken two days after collapse and prior to excavation.

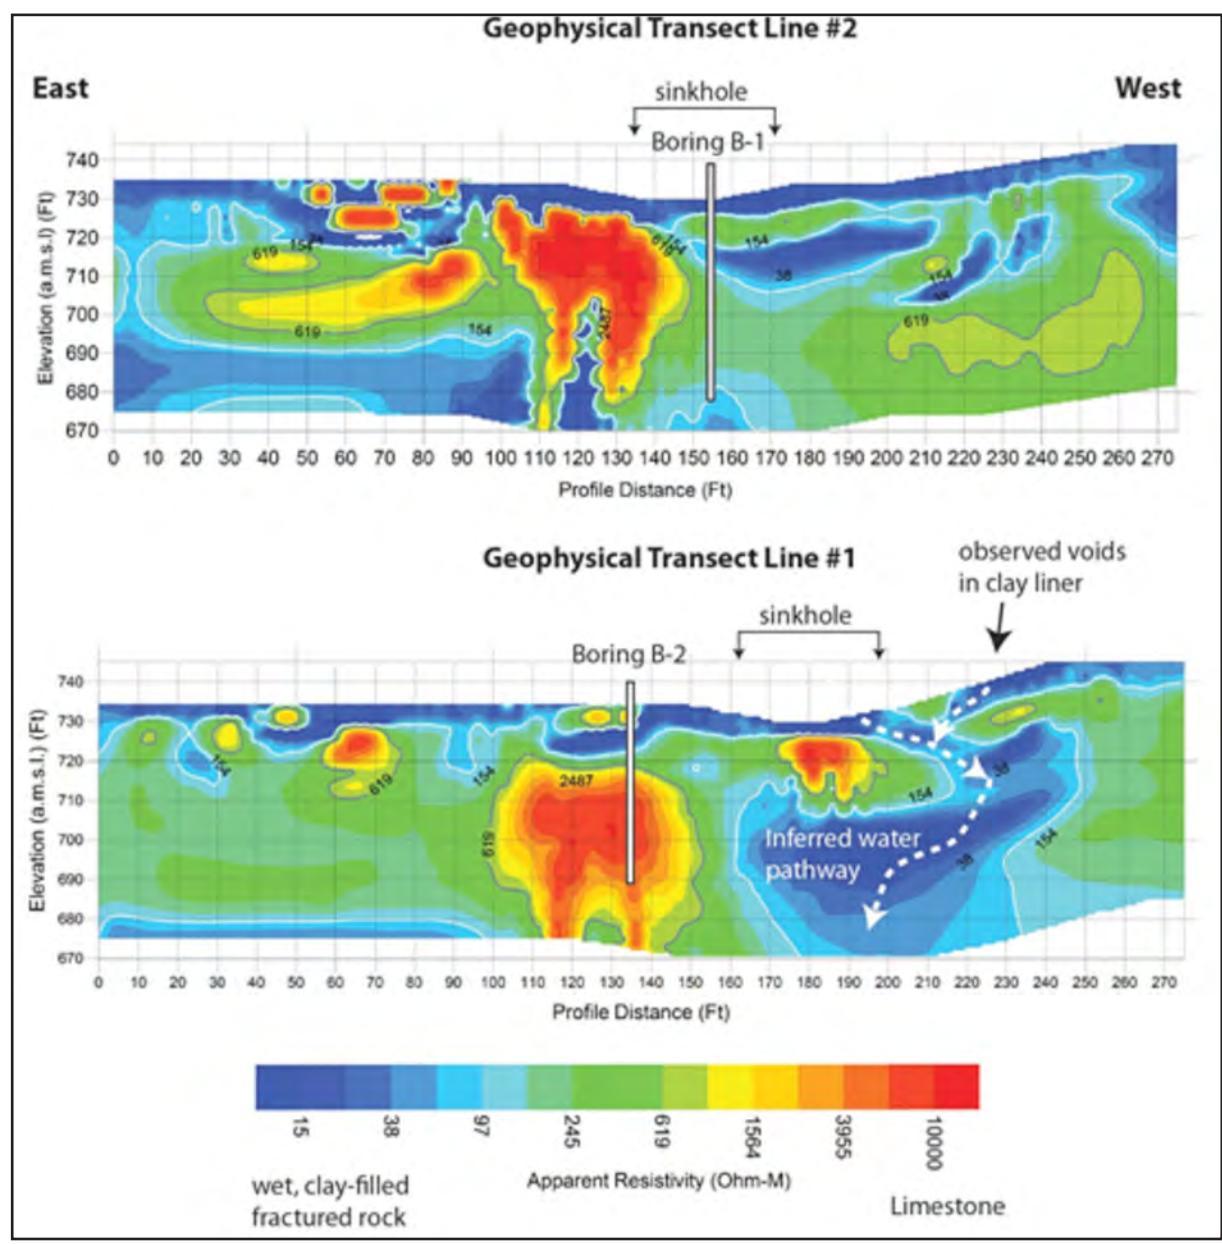
Figure 7. Resistivity profile from lines 1 and 2 (shown on Figure 3). The sinkhole was located between these two lines. Note the interpretation of water infiltration. This is based upon the resistivity data and the voids observed in the compacted clay material of the retention pond.

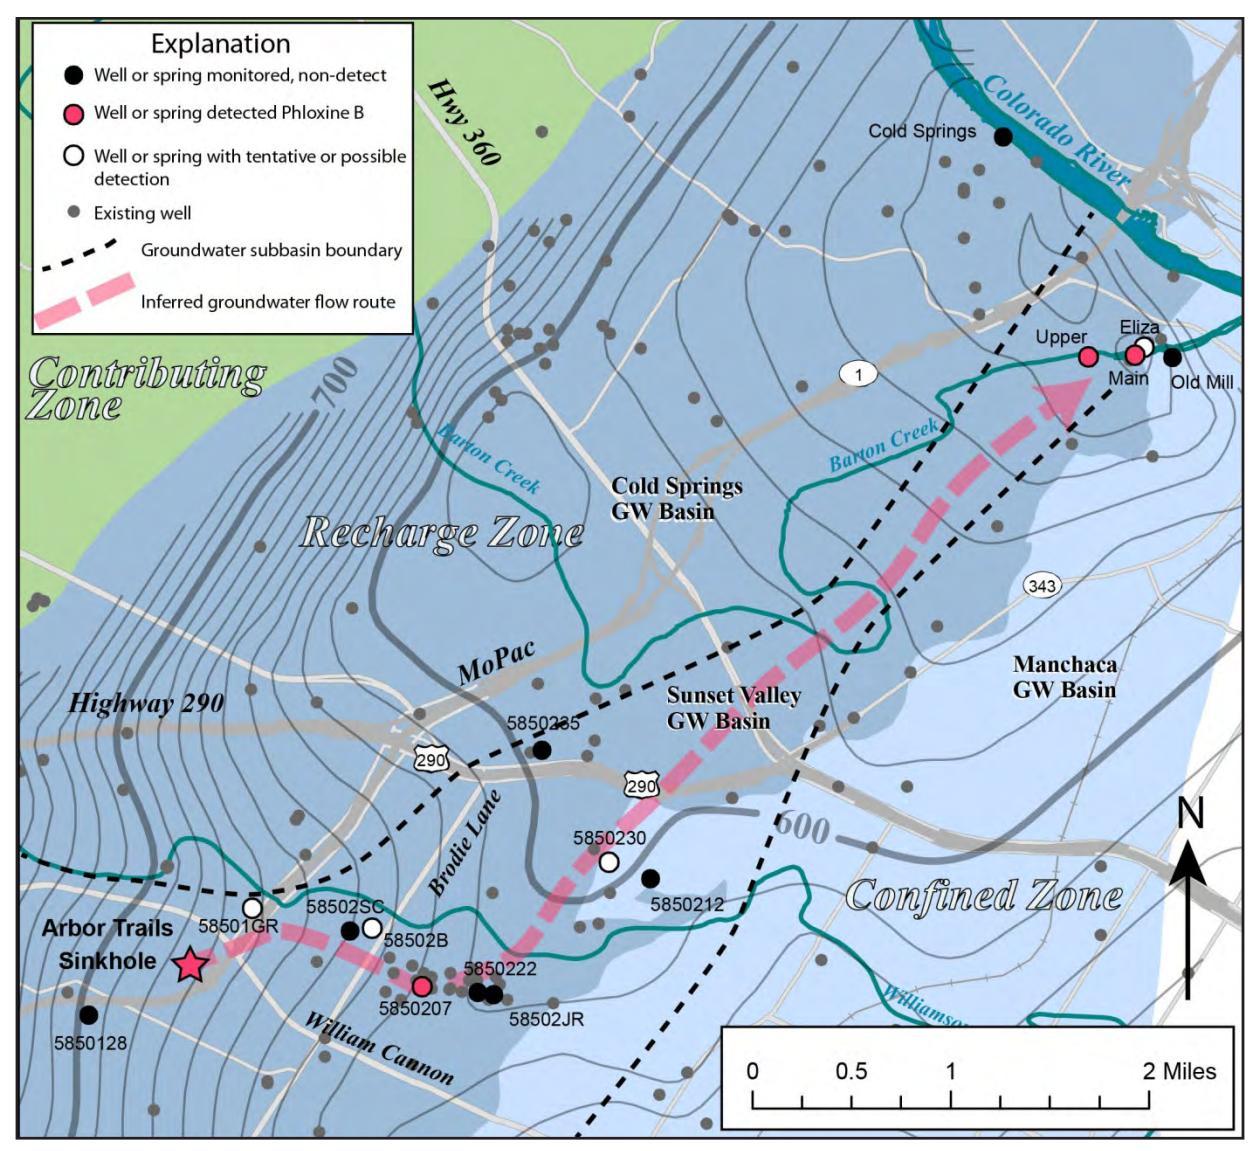
Figure 9. Map of results from the Arbor Trails dye trace. Pink circles indicate positive detections (very high confidence, both labs) of Phloxine B. White circles are wells with tentative detections (single detections from EAA lab), and solid black circles are locations with non-detects (both labs). Dashed pink line represents estimated flow route and is coincident with the "Sunset Valley Flow Route" defined by Hauwert et al., 2004. Small gray circles are existing water-supply wells. Light gray potentiometric lines are from February 2002 high flow conditions (10-ft contour intervals). Groundwater basins are defined in Hauwert et al., 2004.

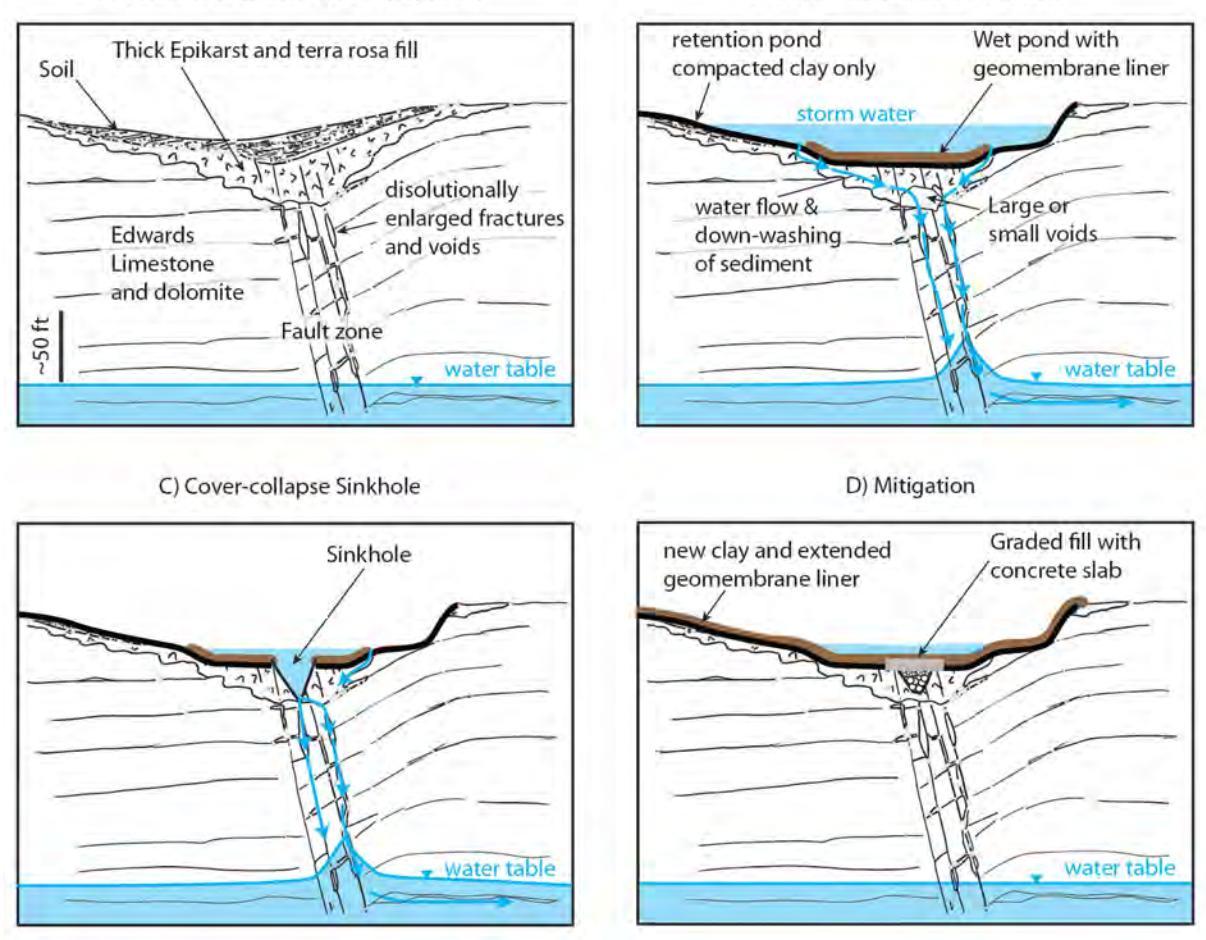
Figure 12. Conceptual hydrogeologic model of sinkhole in four stages: A) Pre-SWRP development, B) SWRP and sinkhole activation, C) cover- collapse, and D) mitigation.

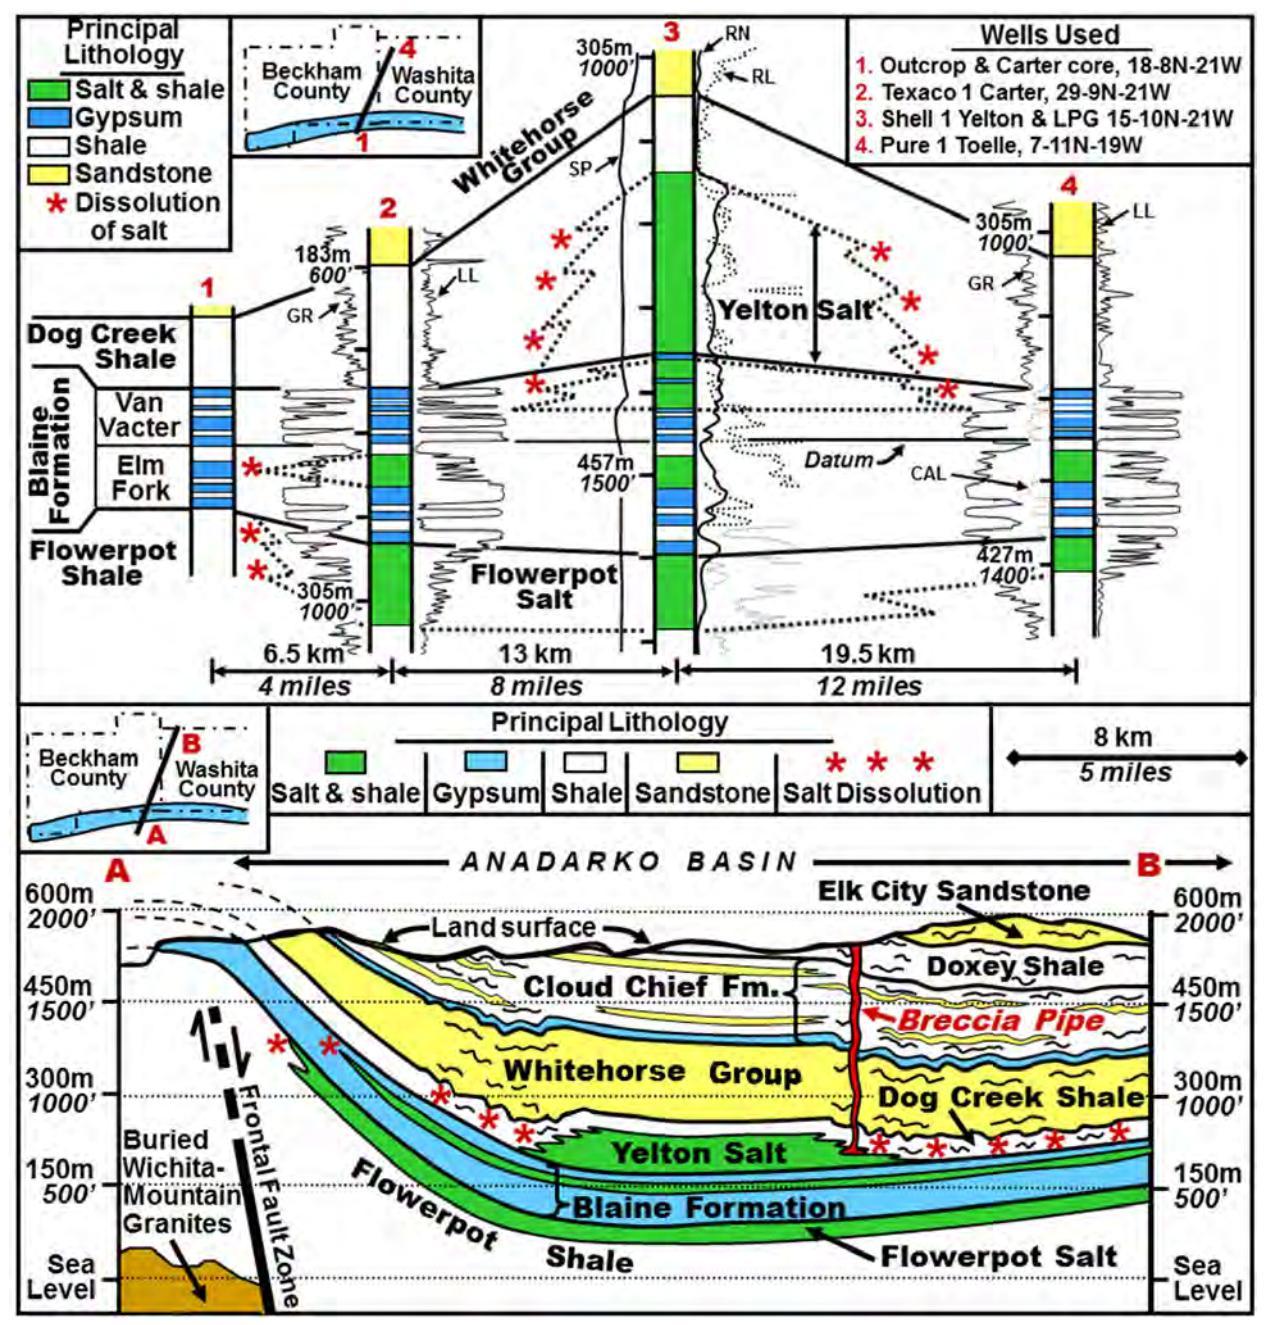
Figure 2. Cross sections showing dissolution of Permian salt units in eastern Beckham and western Washita Counties, Oklahoma. Upper stratigraphic cross section (Johnson, 1967, Plate II) and lower structural cross section (Johnson, 1963) are along the same alignment.

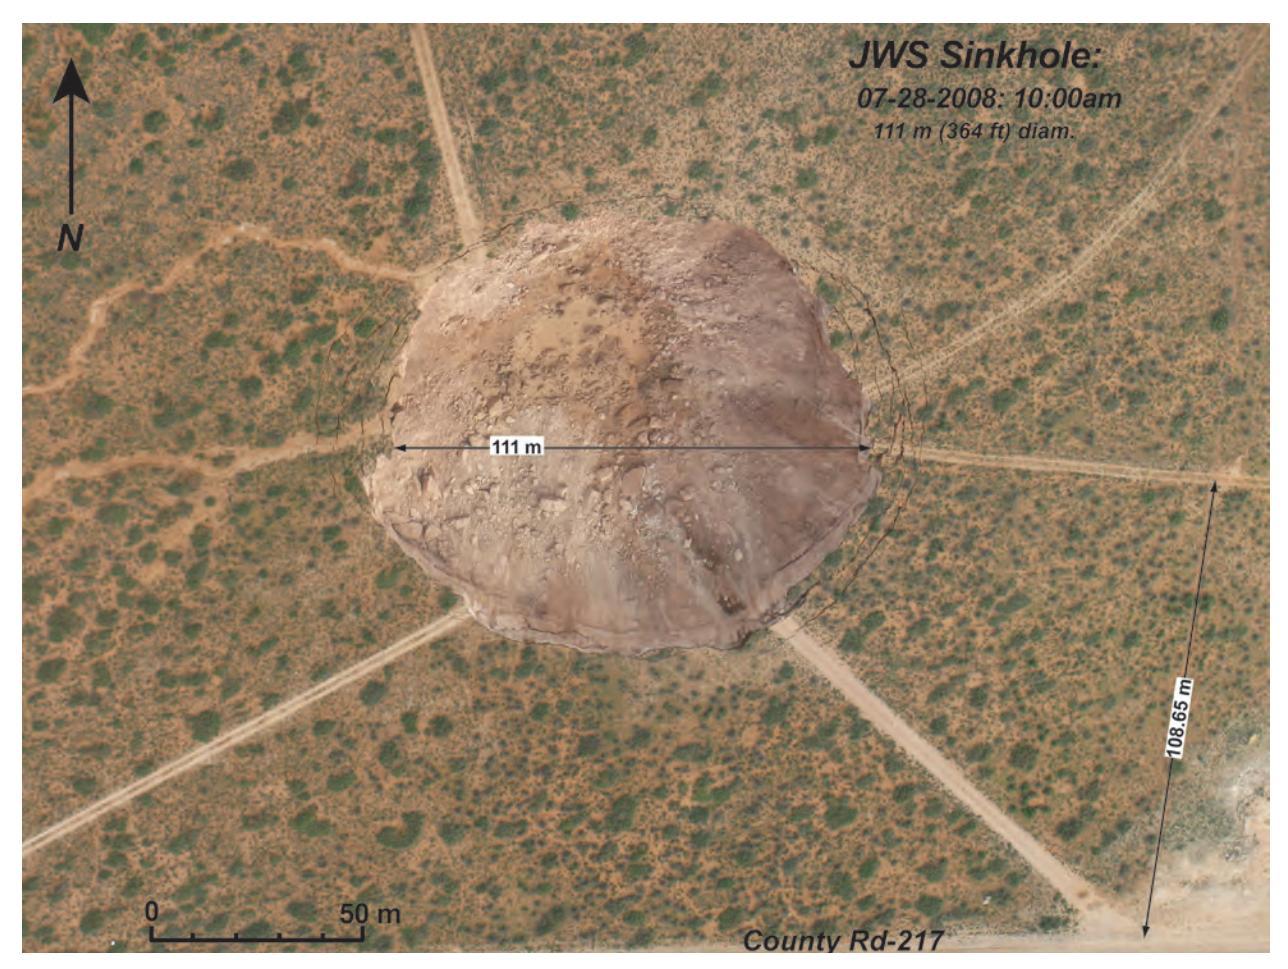
Figure 7. JWS sinkhole on 7/28/2008, showing post-collapse draining and broadening. Note concentric fractures around margins of sink. Boulders in the sinkhole are approximately car-size.

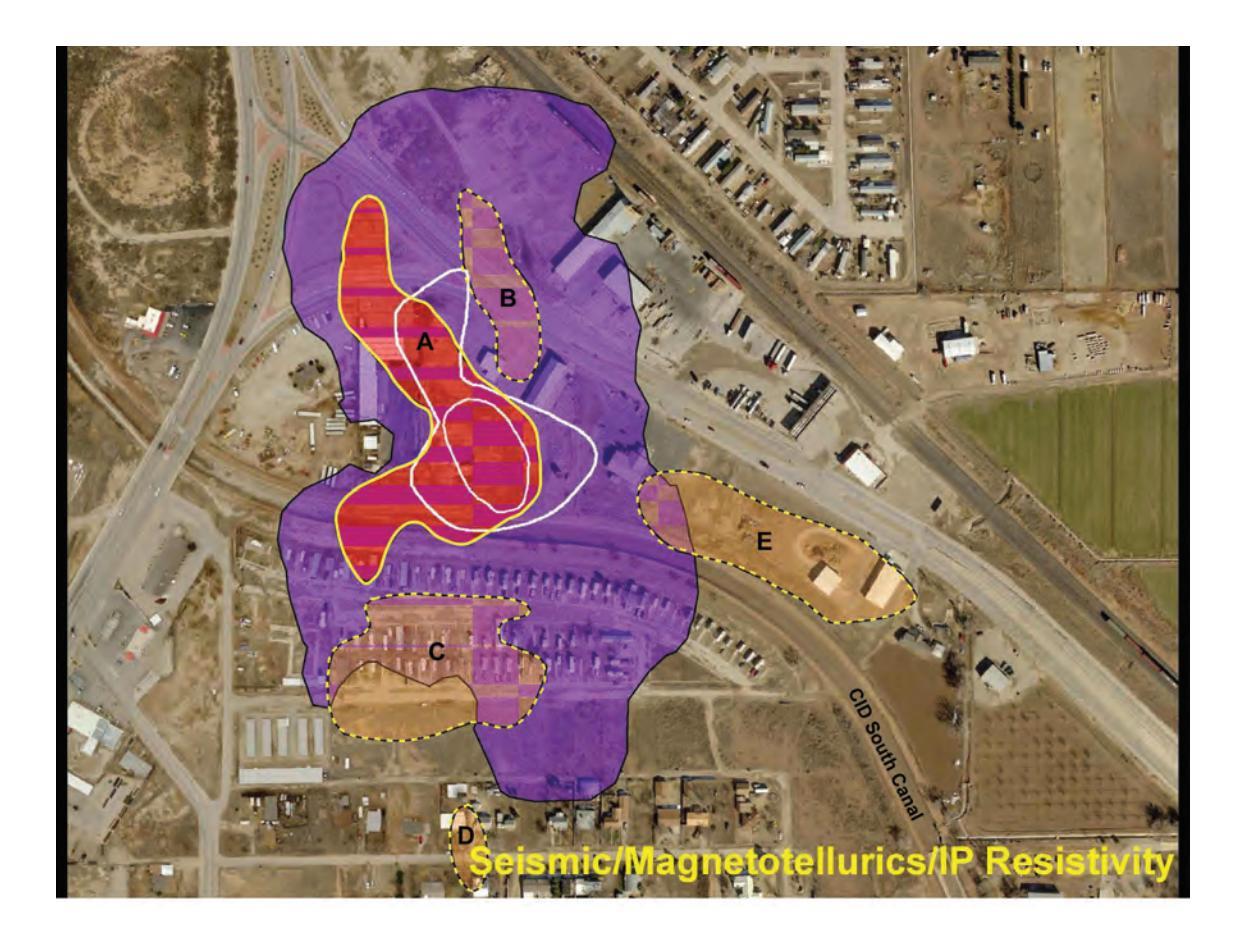
Figure 11. Geophysical surveys conducted at I&W brine well facility from 2009 to 2011. Low resistivity zones A, B, C, D, and E defined by electrical resistivity survey are indicated by solid or dashed yellow lines; red filled area shows probable extent of the cavity excavated by the I&W brine well, as defined by resistivity surveys. Purple shading shows area where magnetotelluric surveys identified subsurface void thickness greater than 3 meters. White outline indicates area where a cavern signature was identified on 2D seismic reflection surveys. Inner white oval shows the area of greatest seismic disruption. Note that none of the seismic lines extended south of the CID South Canal.

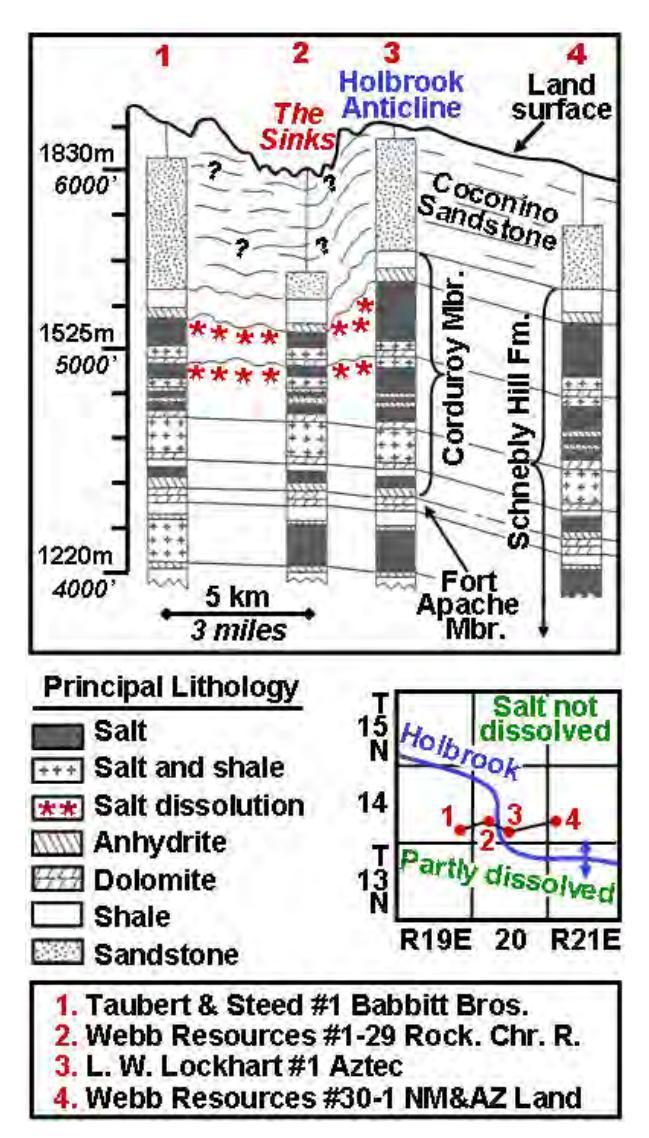
Figure 4. Mechanism of sinkhole collapse along Holbrook Anticline at The Sinks, showing thinning of Corduroy member evaporites in well records (Dean and Johnson, 1989).

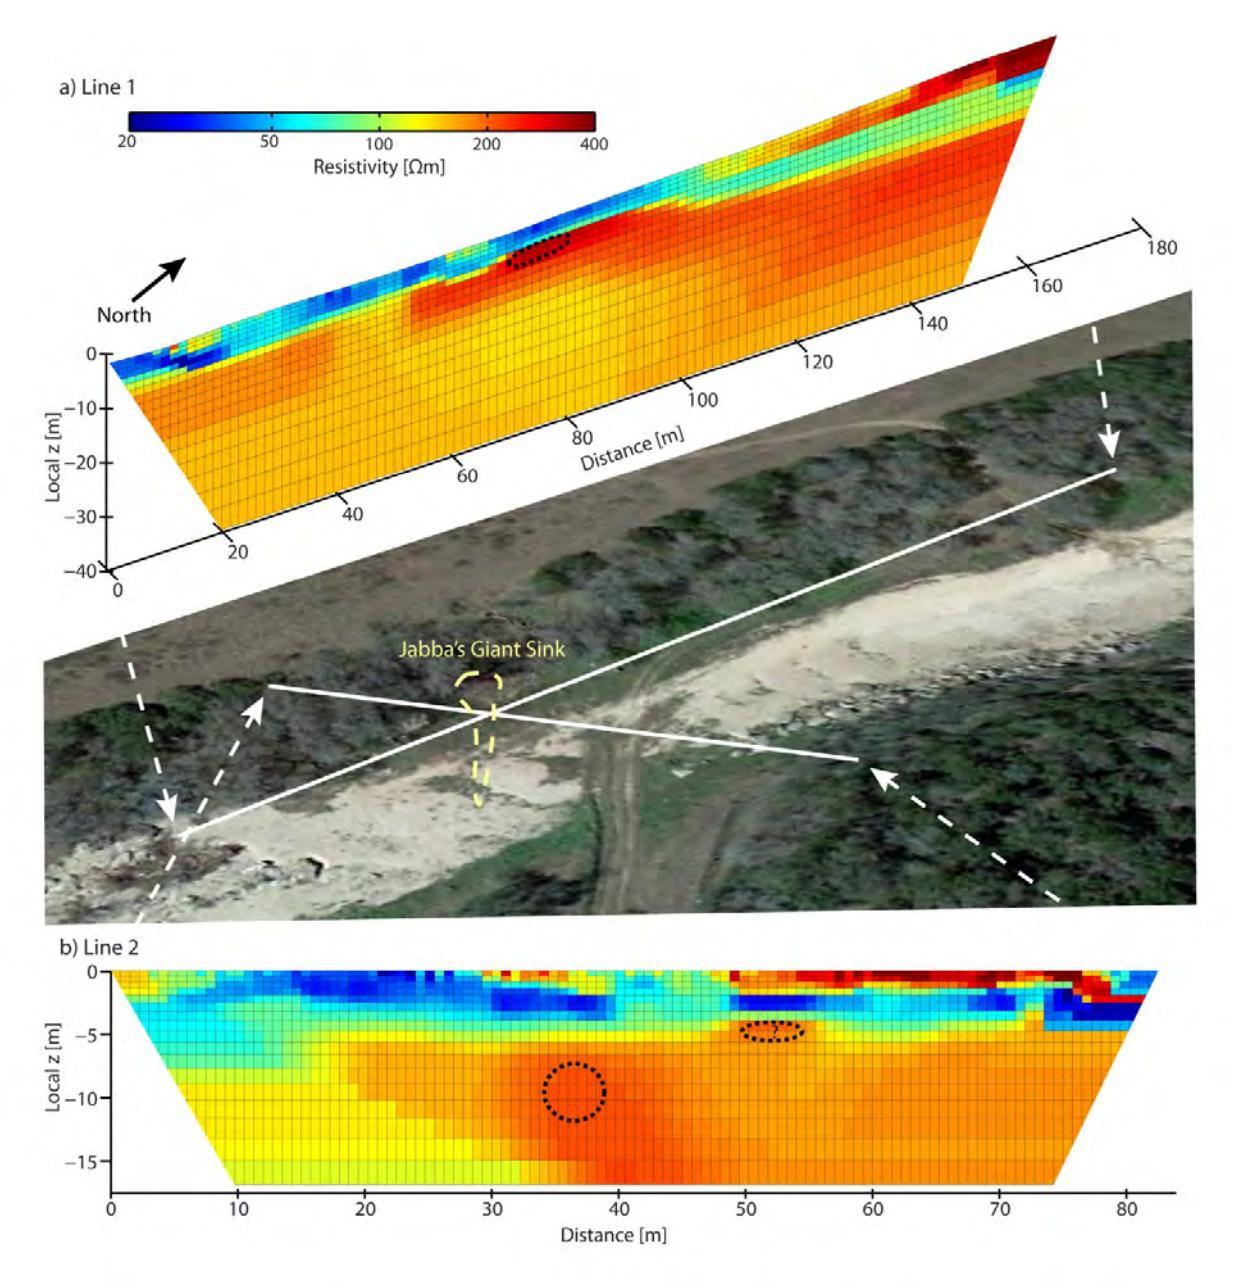
Figure 9. ER results at Jabba's Giant Sink (cave outline shown in orange). Both lines 1 and 2 resolve high ER features where the cave was expected to cross into the surveys (\sim 75 m – line 1; \sim 40 m – line 2). Line 2 may have resolved a shallower cavity (\sim 50 m).
