NCKRI SYMPOSIUM 2 Proceedings of the 13th Multidisciplinary Conference on Sinkholes and the Engineering and Environmental Impacts of Karst

PROCEEDINGS OF THE THIRTEENTH MULTIDISCIPLINARY CONFERENCE

May 6 through 10, 2013 Carlsbad, New Mexico

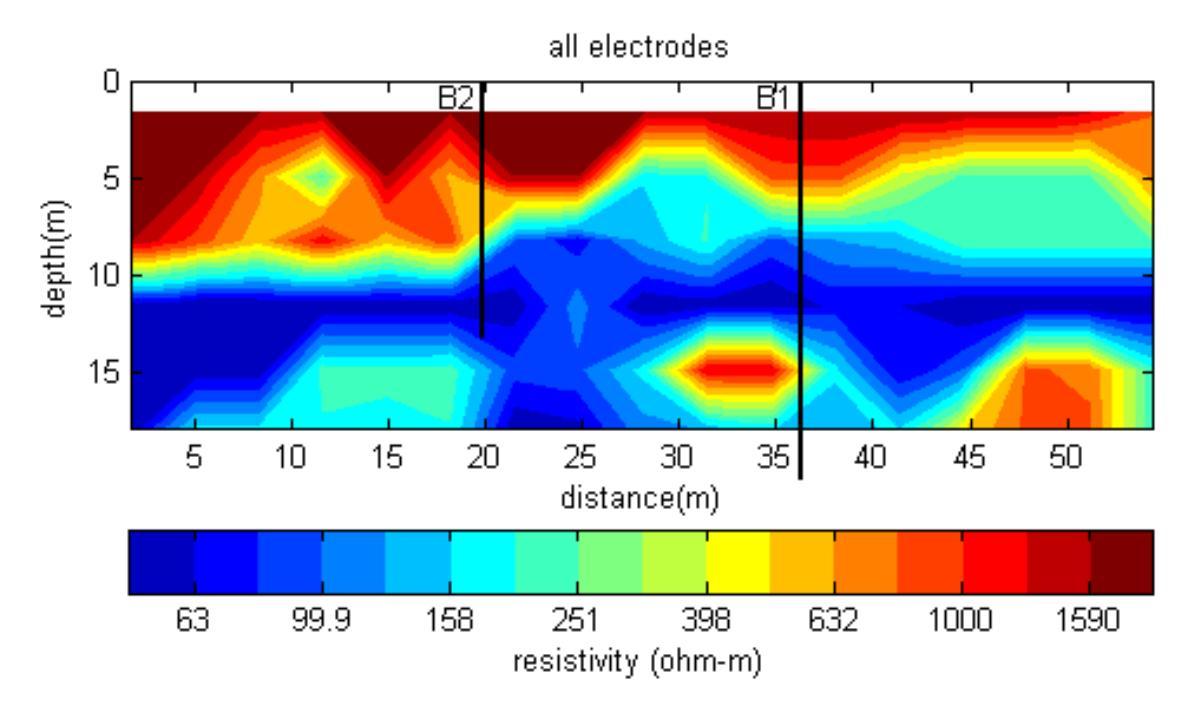
Figure 6. As for Figure 4, but incorporating readings from electrodes at depth. This inversion includes the traditional surface dipole-dipole array, the equivalent dipole-dipole array at 10 meters depth, and readings with current electrodes at surface and potential electrodes at depth. In this inversion, zones of higher resistivity are observed at depths where the limestone was reached in SPT borings.

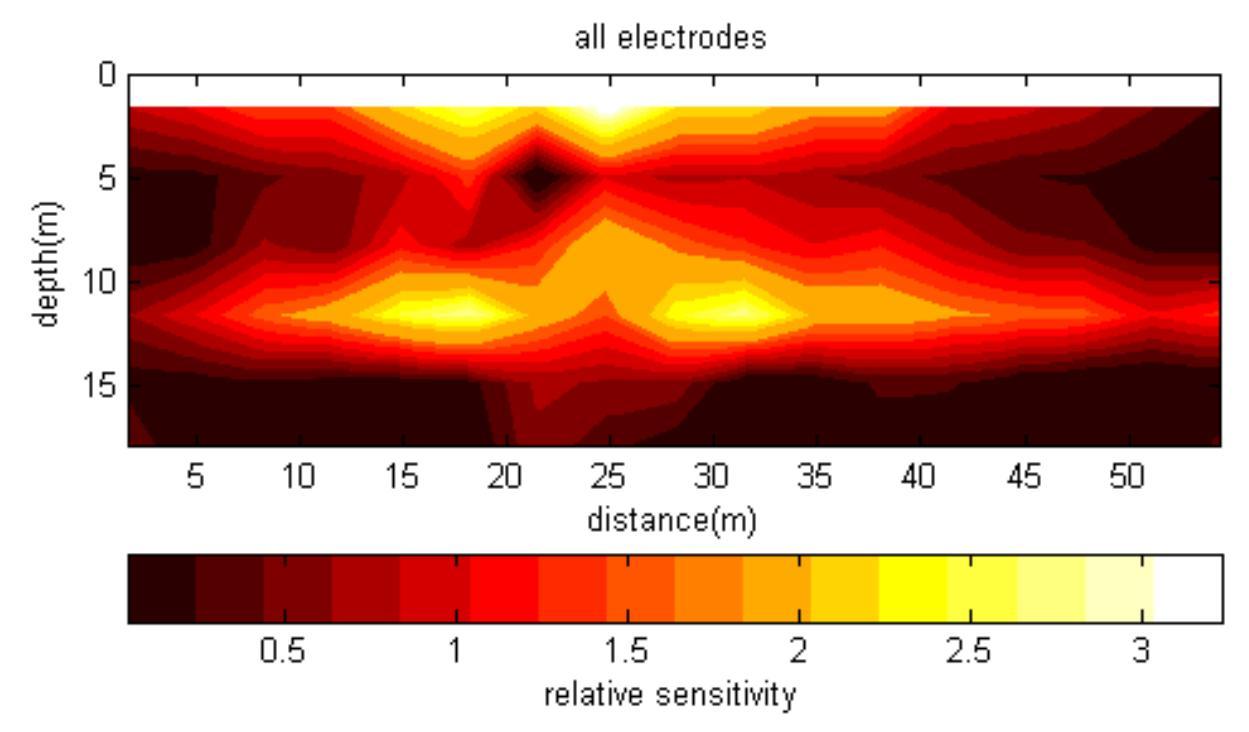
Figure 7. Relative sensitivity of the resistivity survey data when incorporating readings from electrodes at 10 meters depth. Compare to Figure 5; note the increased sensitivity at depths of 10-13 meters.

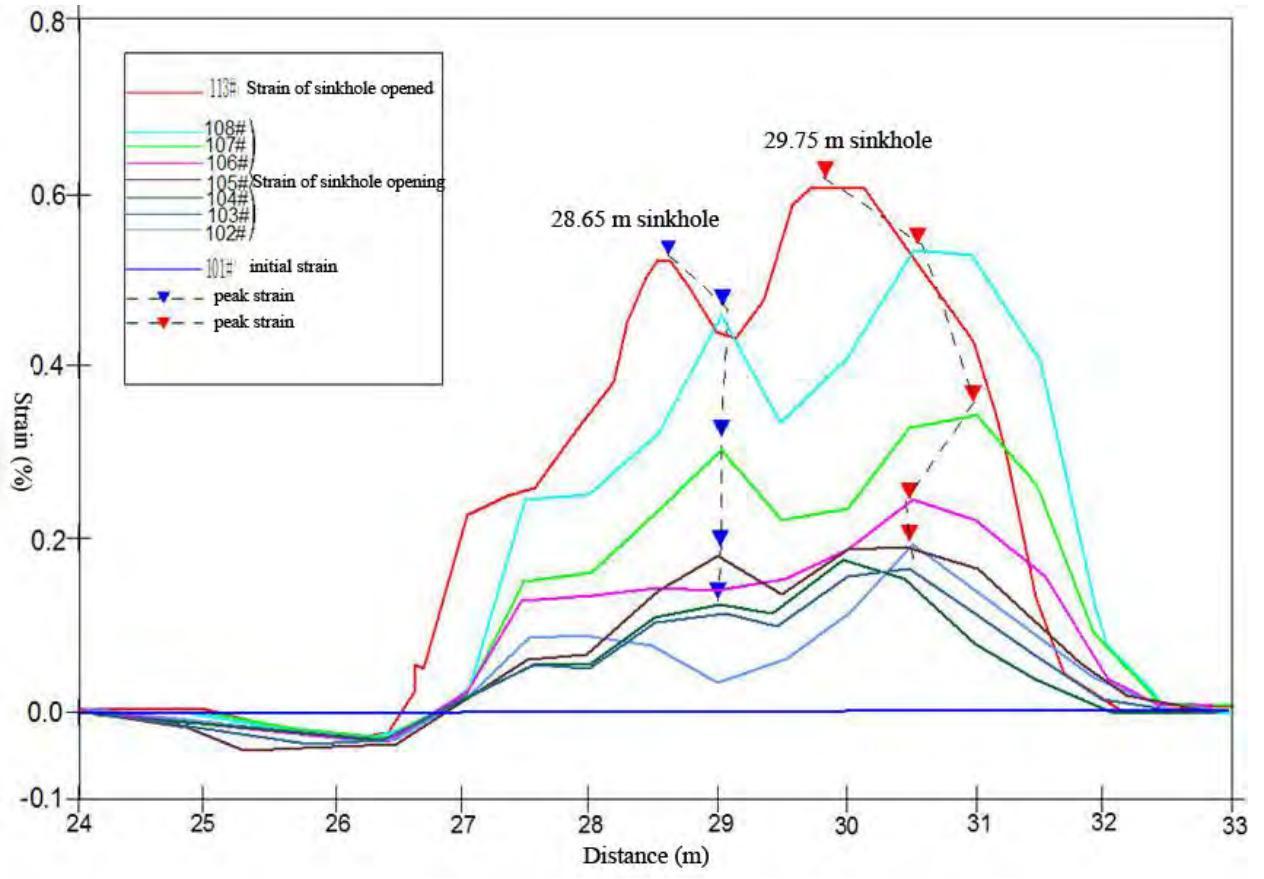
Figure 6. Strain curve from optical fiber during sinkhole opening

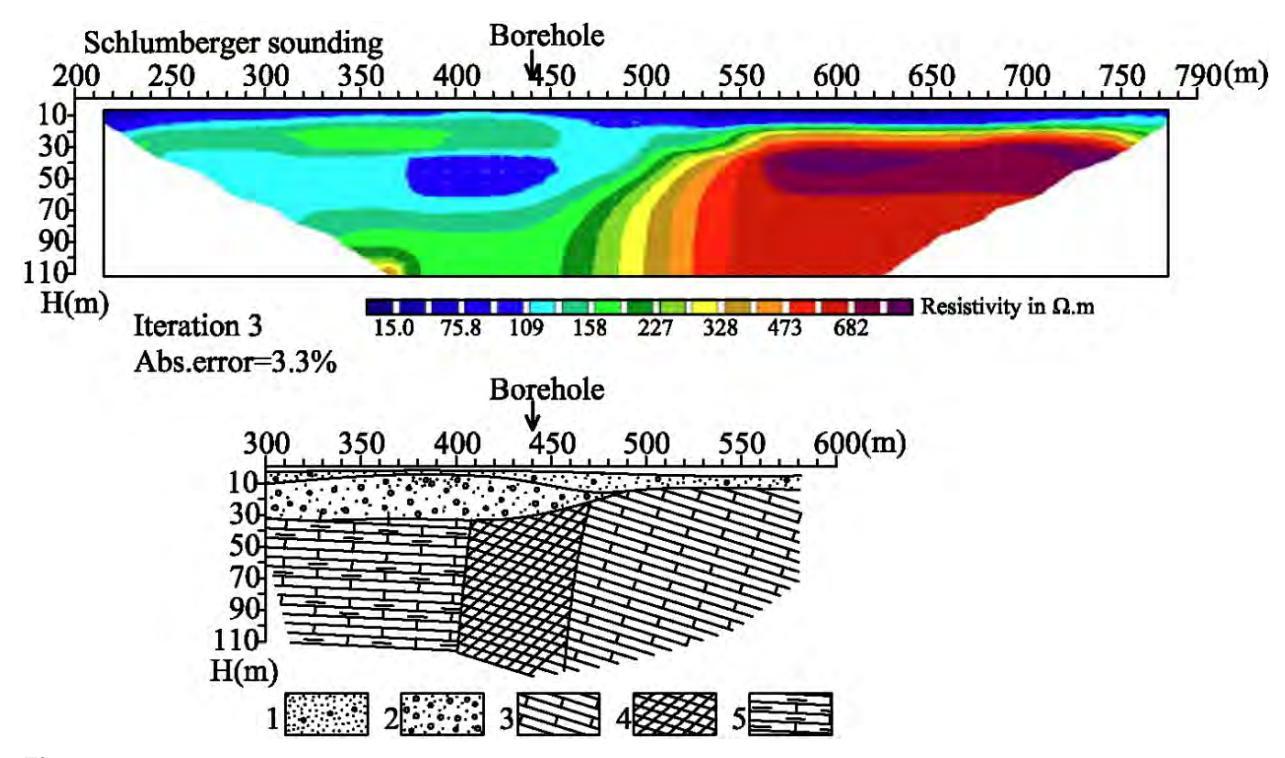
Figure 4. Resistivity imaging (upper), Geological interpretation for profile 5 (lower) 1. Fine sand with gravel, 2. Gravel with fine sand, 3. Limestone, 4. Karst fissures, 5. Interbedded limestone and shale.

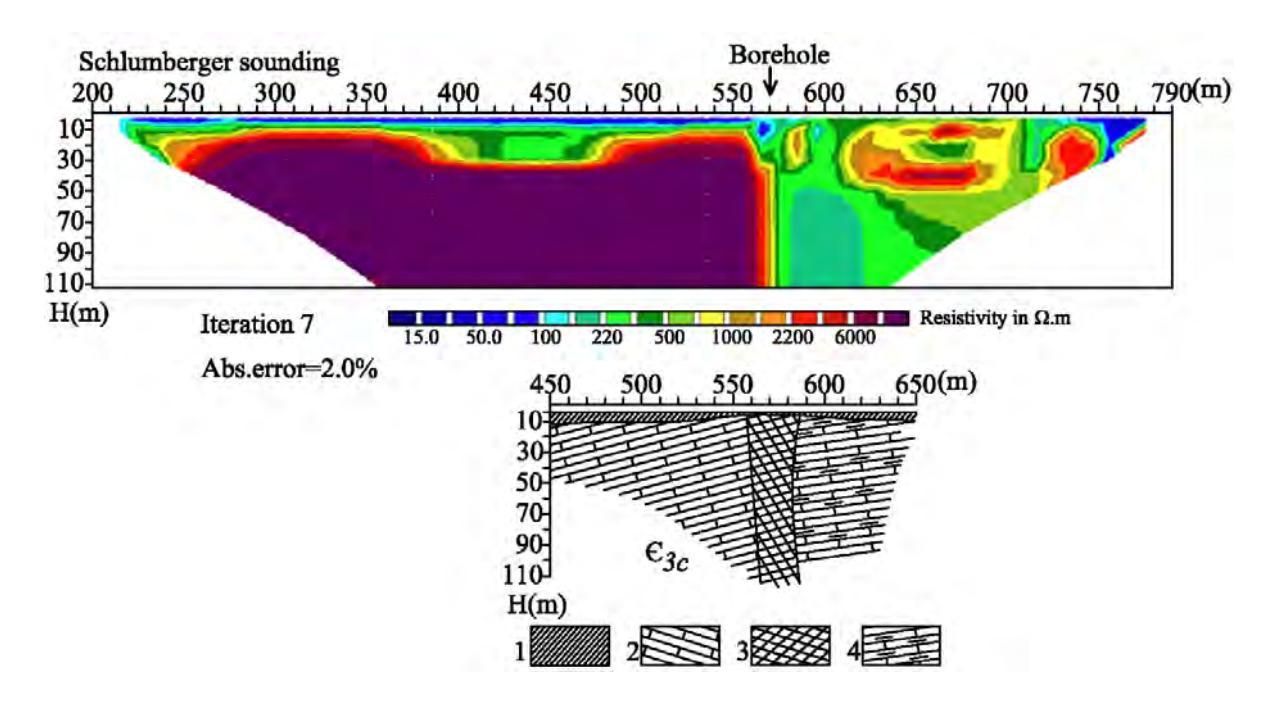
Figure 7. Resistivity imaging (upper), Geological interpretation for line 1 (lower) 1. Clay, 2. Limestone, 3. Karst fissures, 4. Interbedded limestone and shale.

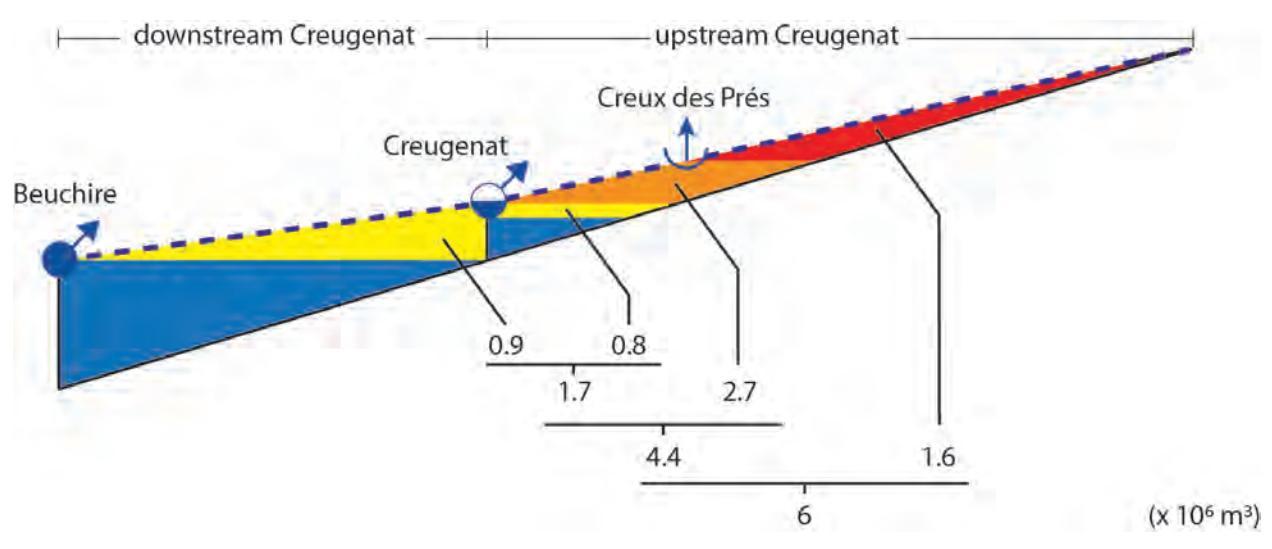
Figure 12. Model predicted storage in the aquifer (i.e. the karst conduits) and its development due to groundwater increase within the karst system for the respective flood events (average annual, 30-year flood events and ~300-year flood events). The associated volumes refer to water potentially involved in the floods (1.7 Mm3 for an average annual flood event, 4.4 Mm3 for a 30-year flood event and more than 6 Mm3 for a 300-year flood event).

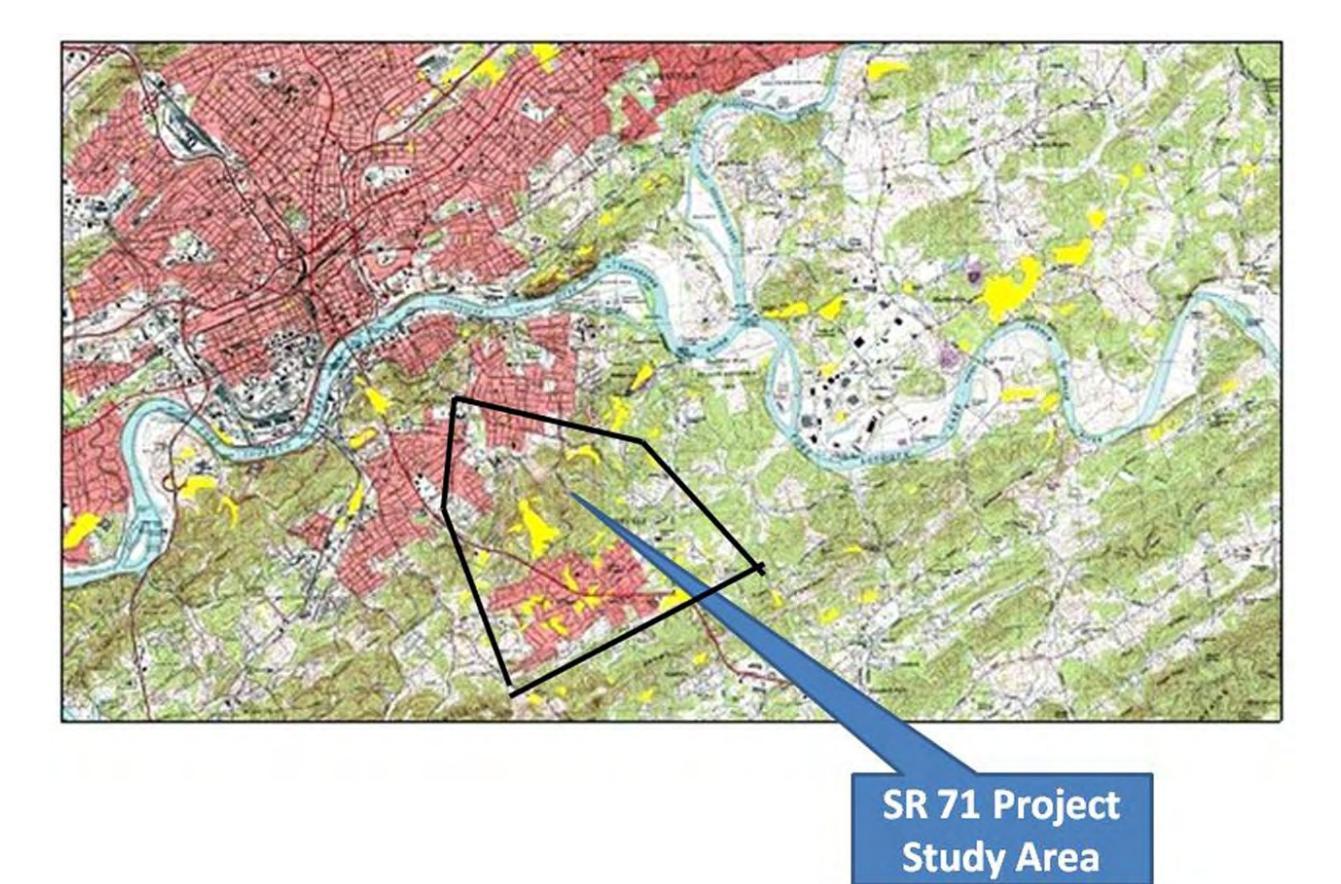
Figure 4. This sinkhole map was prepared for the geohazard study for the SR 71 project; yellow areas are sinkholes that were found based on a 20-foot contour interval.

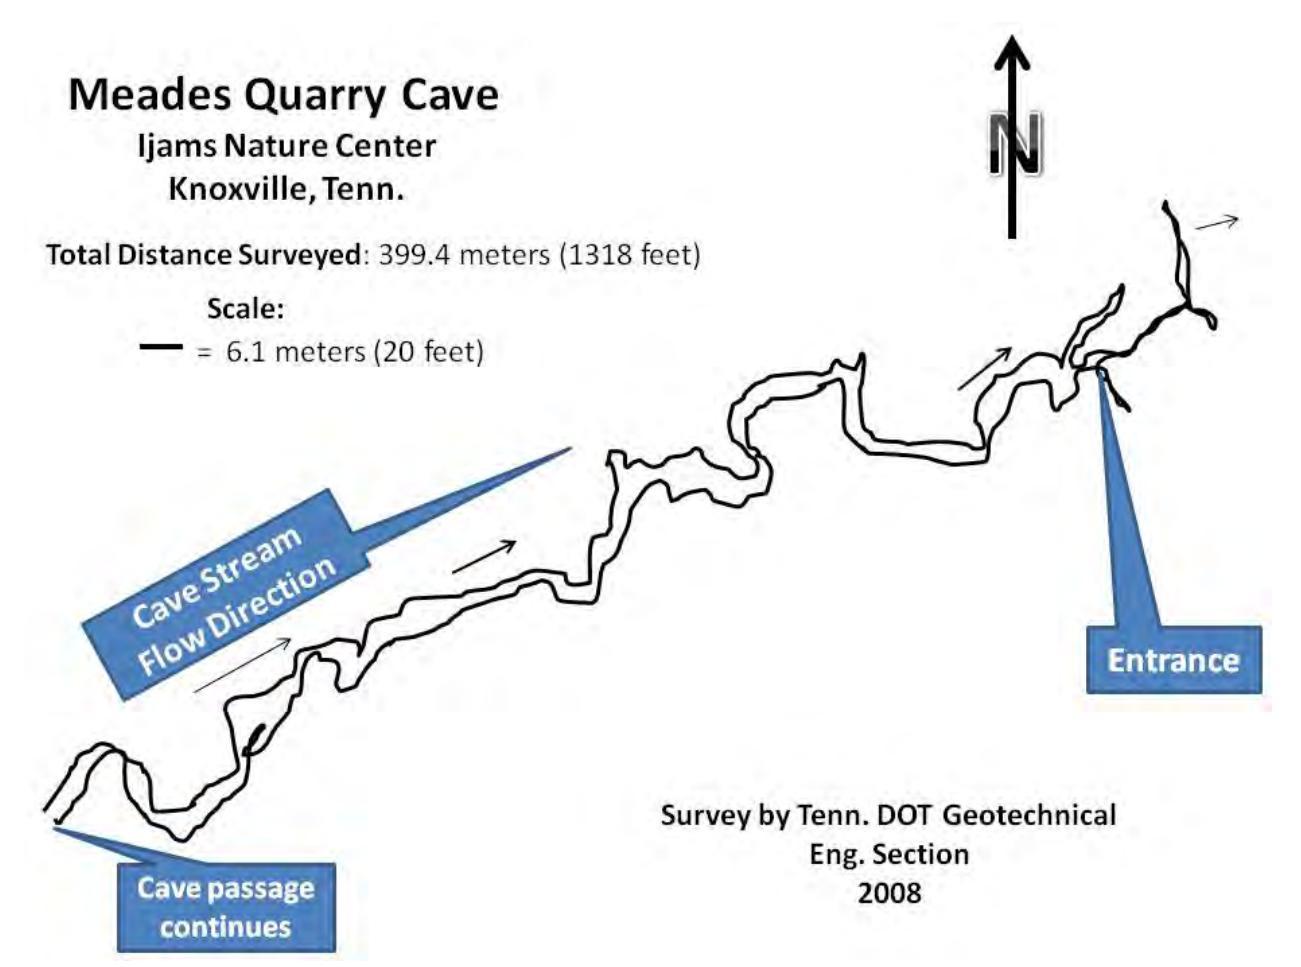
Figure 10. This map of Meades Quarry Cave, made by the TDOT Geotech section, shows the general stream flow direction, which is parallel to the bed rock strike direction.
